INDOOR AIR QUALITY ASSESSMENT

**Crowell Elementary School
26 Belmont Ave
Haverhill, Massachusetts 01830**

Prepared by:
Massachusetts Department of Public Health
Center for Environmental Health
Bureau of Environmental Health Assessment
Emergency Response/Indoor Air Quality Program
June 2004

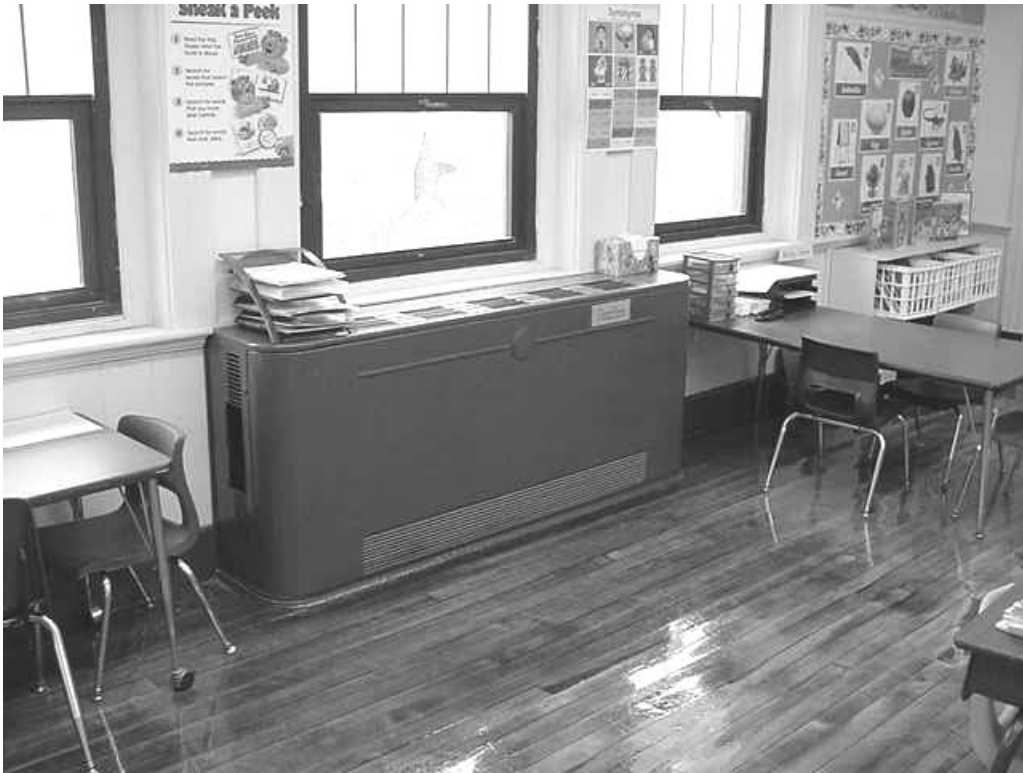
Picture 1

Fresh air in classrooms of these sections of the building was originally supplied by a unit ventilator (univent) system (Picture 1). Univents are designed to draw air from outdoors through a fresh air intake located on the exterior walls of the building (Picture 2) and return air through an air intake located at the base of each unit ([Figure 1](#)). Univents were deactivated in all classrooms throughout the school. Obstructions to airflow, such as furniture located in front of and/or materials stored on univents, were observed (Picture 3). In order for univents to provide fresh air as designed, these units must remain activated and allowed to operate while rooms are occupied. In addition, air diffusers and return vents must remain free of obstructions. Due to the age and condition of the univent system, it may not be feasible to reactivate the univents without a complete refurbishment or replacement. Open windows seems to be the only viable way to introduce fresh air into classrooms.

Classroom univent

1. Continue with remediation efforts in the basement areas.
2. Consider consulting a heating, ventilation and air conditioning (HVAC) engineer concerning the operability of univents. Consideration should be given to replacing univents.
3. Consider re-establishing a functional exhaust ventilation system for classrooms, if univents are to be replaced.

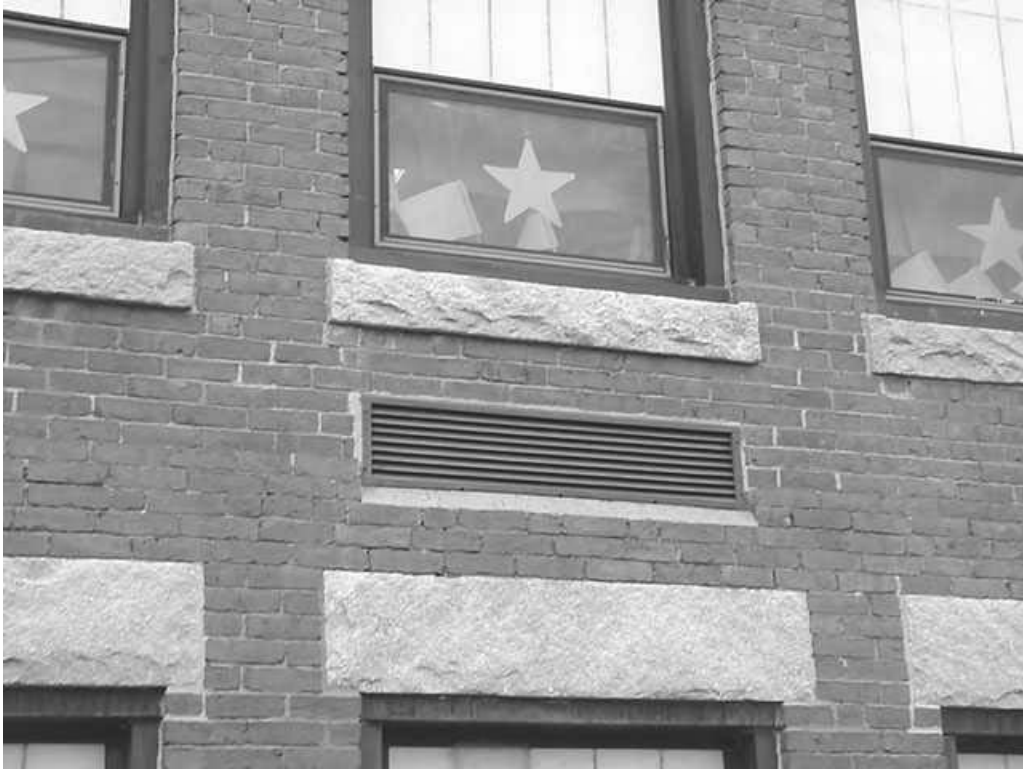
Picture 2

Exterior fresh air intake

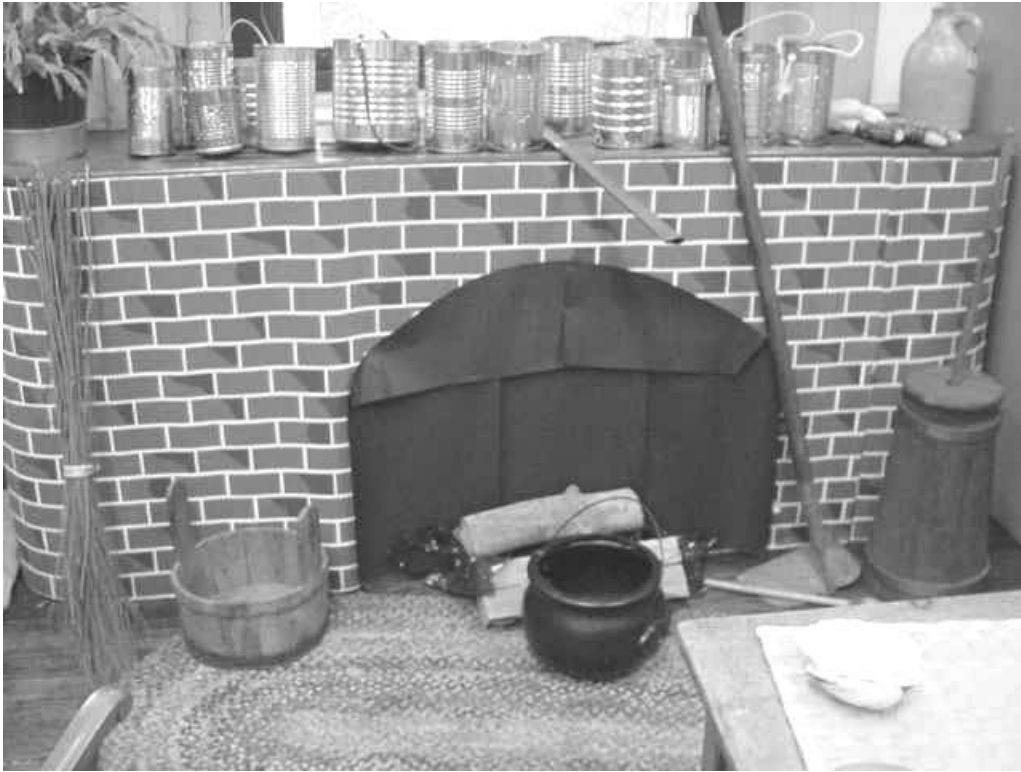
Picture 3

Univent disguised as fireplace and blocked by aluminum cans

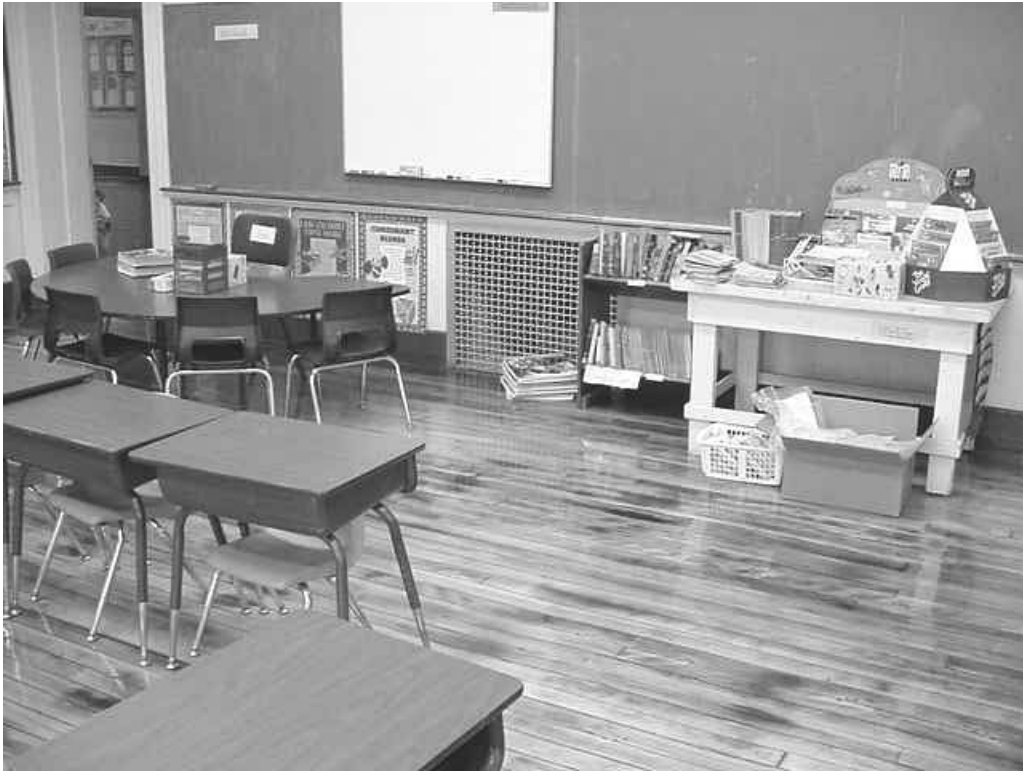
Picture 4

Grated wall exhaust

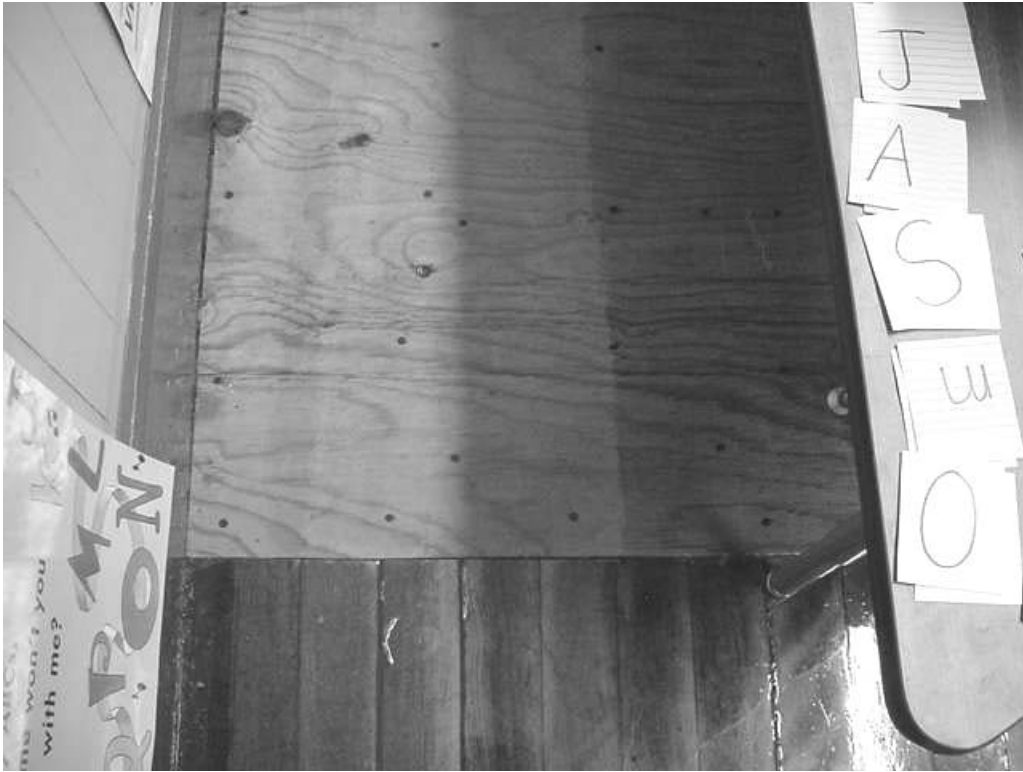
Picture 5

Sealed floor exhaust

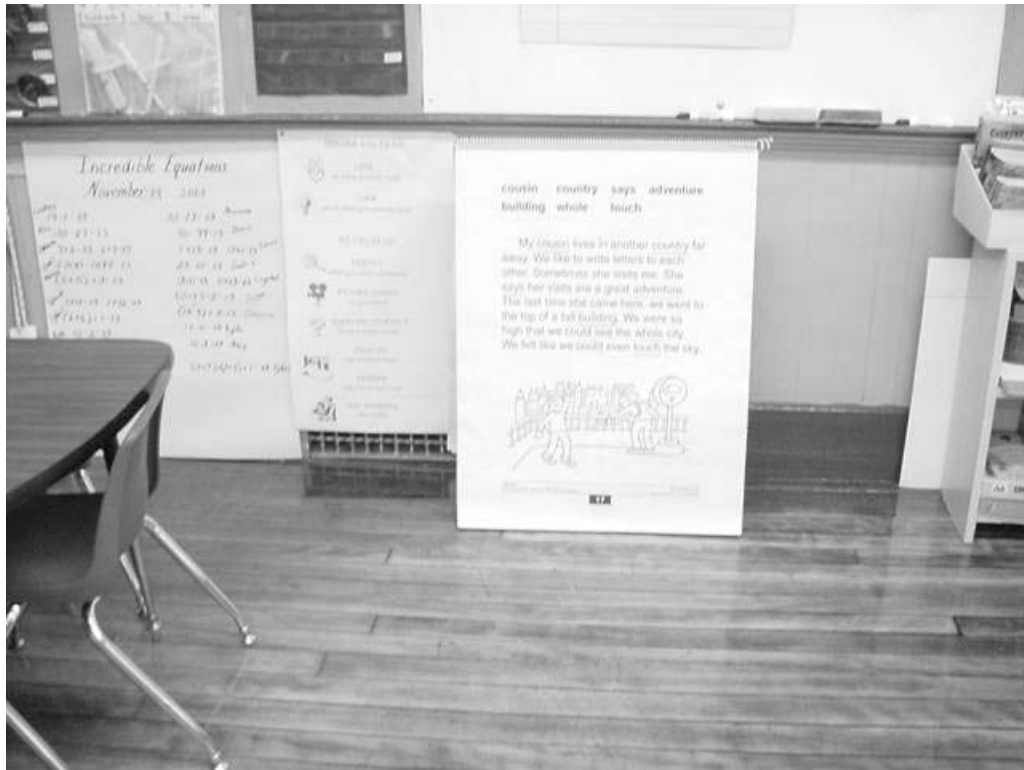
Picture 6

Exhaust ventilation was originally provided by a gravity exhaust ventilation system. Exhaust ventilation is created through the rising of hot air. Typically, a heating element is located at the bottom of the airshaft. Air warmed by the heating element rises up the airshaft, which then draws air from the each room into the shaft via grated floor or wall vents (Picture 4). Operation of univents would also provide slight positive pressure, moving air towards the grated exhaust vents. Once classroom air enters the exhaust shaft, it moves upwards and exits the building. According to maintenance staff, the gravity exhaust system has been deactivated. All of the floor grates on the first floor had been sealed and refinished (Picture 5). Wall grates on the second floor remain open; however, many are currently blocked (Picture 6).

Blocked grated wall exhaust

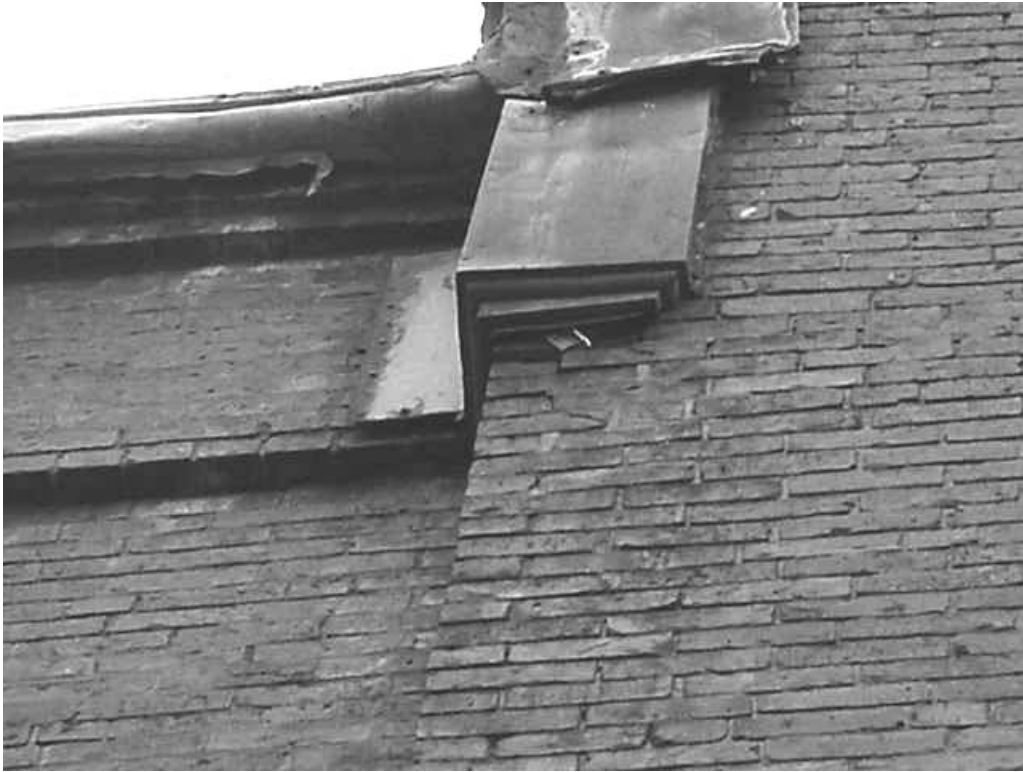
Picture 7

As previously discussed, the school has a history of water damage problems. According to staff, the conditions of the roof and gutter system allowed for water to penetrate the building. During the MDPH assessment, BEHA staff members conducted an inspection of the building exterior and noted the conditions of the gutter and drain systems. In its original design, the gutter system would collect and move water towards drains that moved water down and away from the building. However, the original gutter and drain system is no longer intact. This condition allowed water to flow against the building. Water running against the building has caused discoloration to the building exterior and damage to brick and mortar (Picture 7). Mortar

Damaged and discolored brickwork

5. Consider repointing brickwork.
6. Operate all ventilation systems that are operable throughout the building (e.g., gym, auditorium, classrooms) continuously during periods of school occupancy and independent of thermostat control to maximize air exchange.

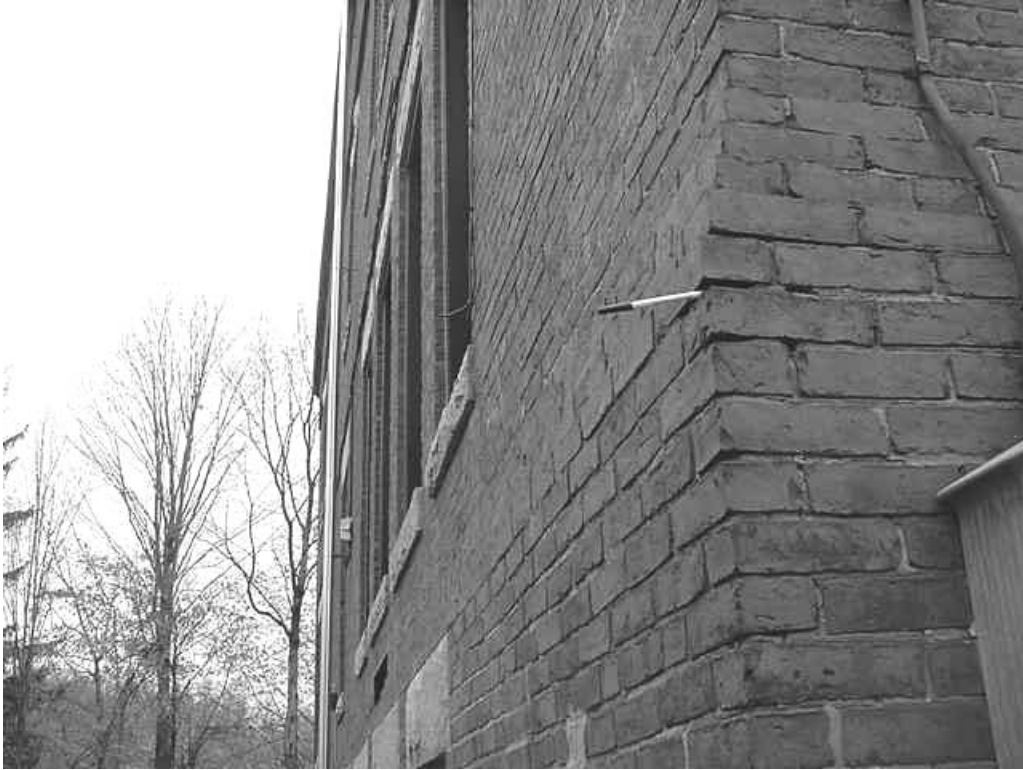
Picture 8

was also eroded in other portions of the building (Picture 8). At the time of the assessment, Haverhill school officials indicated that the roof and gutter system had been replaced. BEHA staff noted the drainage system replacement (Picture 9).

Eroded mortar on building exterior (Pen Insert by BEHA staff to show size of space in mortar)

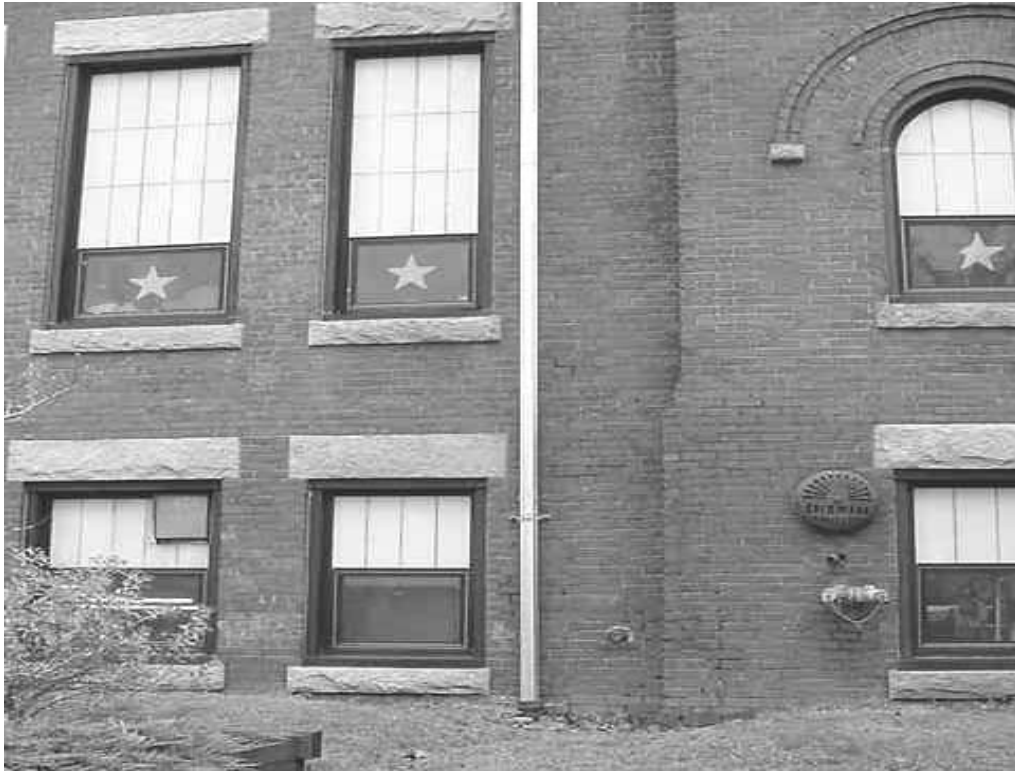
Picture 9

Roof drain installed prior to assessment

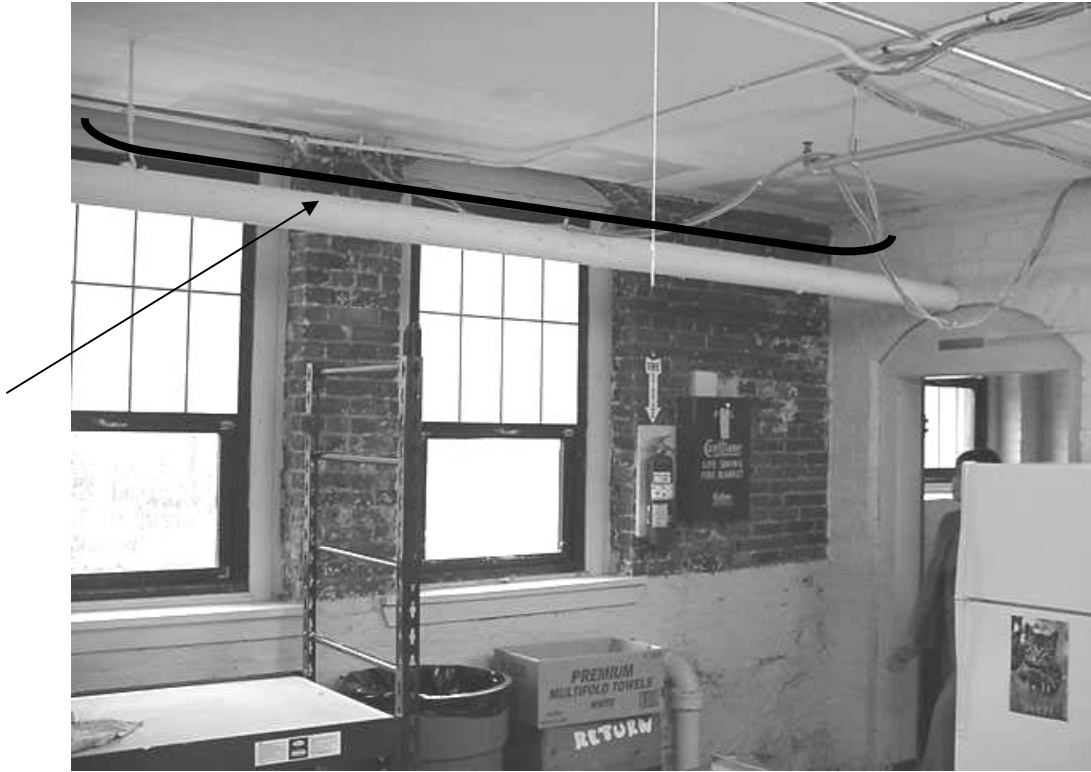
Picture 10

New gypsum wallboard ceiling in cafeteria

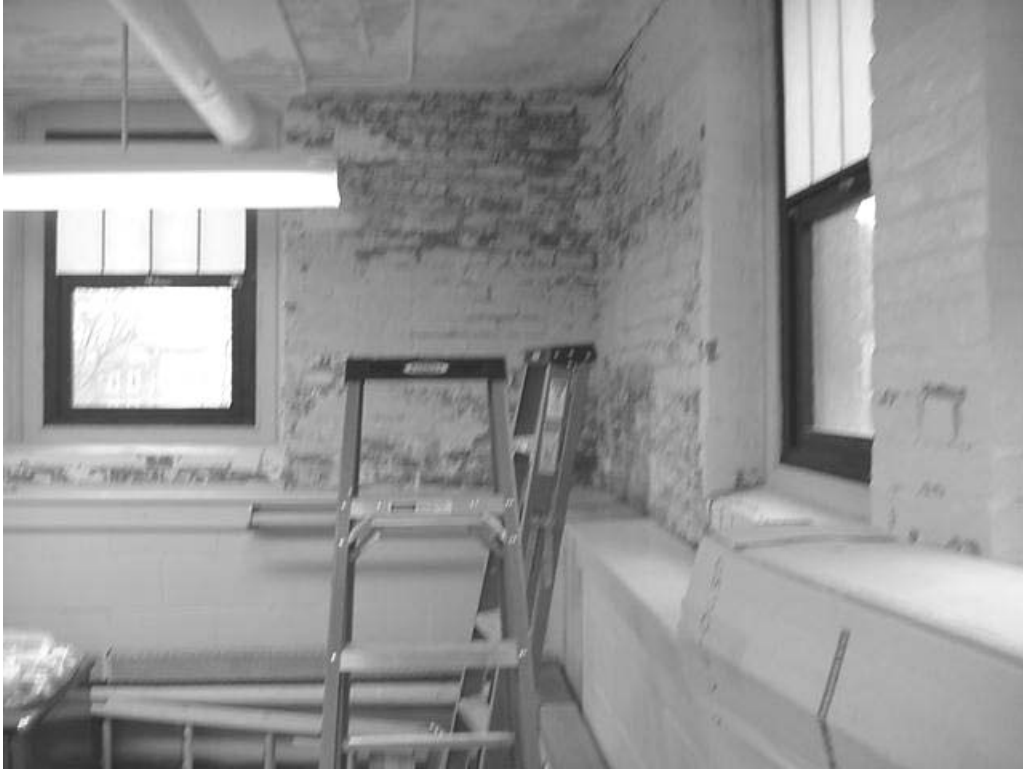
Picture 11

Art room under renovation

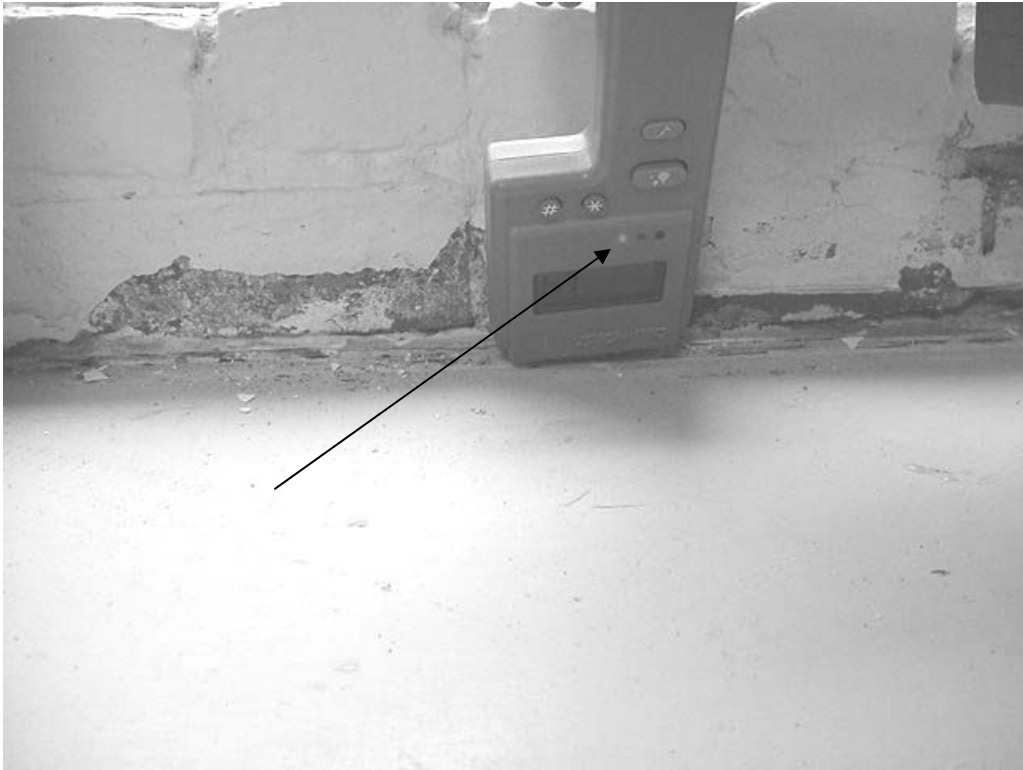
Picture 12

At the time of the assessment, maintenance staff were in the process of repairing water damaged components in the school. Water damaged ceiling material in the cafeteria had been replaced (Picture 10) and the art room was under renovations (Picture 11). BEHA staff examined the exterior facing walls of the art room for water damage. Moisture readings of water damaged wall materials were also taken with a Delmhorst, BD-2000 Model, Moisture Detector with a Delmhorst Standard Probe. The Delmhorst probe is equipped with three lights that serve as visual representations of moisture level. Materials that activate the green light indicate a sufficiently dry level (0 - 0.5%), those that activate the yellow light indicate borderline conditions (0.5 – 1.0%) and those that activate the red light indicate elevated moisture content (> 1%). The probe was inserted into water-damaged wood located between the wall and a bookshelf along windows in the art room. Elevated moisture levels were measured in the wood, indicating that it was moistened from water penetration through art room window frames (Picture 12).

Moisture meter with red light lit

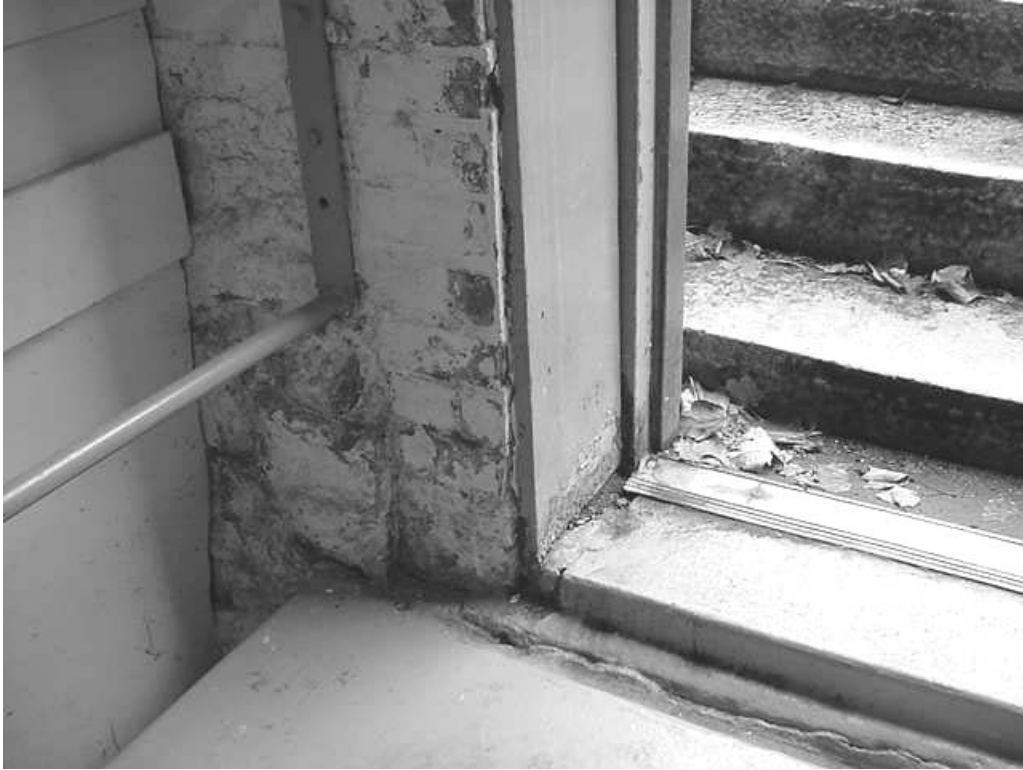
Picture 13

Other points of water penetration were also noted. The doorway between the art room and library is another point where water is penetrating into the building. The doorframe and wall show signs of water damage (Picture 13).

Water damaged wall and door frame

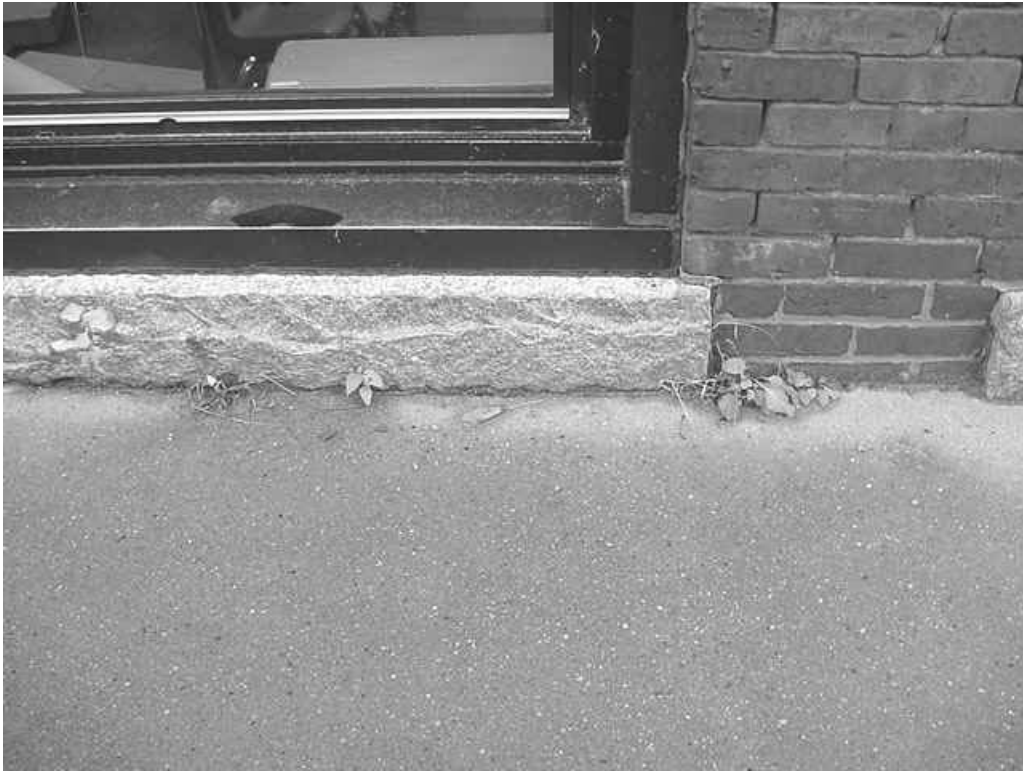
Picture 14

Shrubbery and other plants were growing in close proximity to foundation walls (Picture 14). The growth of roots against the exterior walls can bring moisture in contact with wall brick. Plant roots can eventually penetrate the brick, leading to cracks and/or fissures in the below ground level foundation. Over time, this process can undermine the integrity of the building envelope, providing a means of water entry into the building through foundation concrete and masonry by capillary action (Lstiburek & Brennan, 2001).

Plants growing in creak between wall and ground

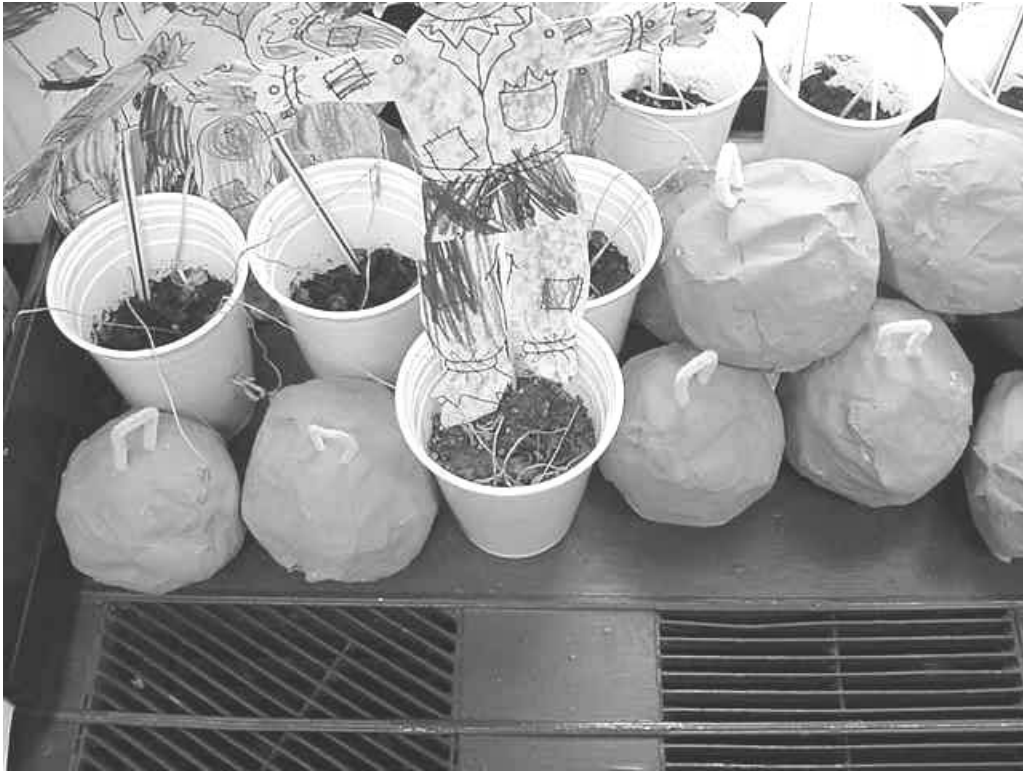
Picture 15

Lastly, plants were located on windowsills or near windows in several classrooms. Some plants were found on top of univents (Picture 15). Plants, soil and drip pans can serve as sources of mold growth, thus should be properly maintained. Over-watering of plants should be avoided and drip pans should be inspected periodically for mold growth. Plants should also be located away from univents and ventilation sources to prevent aerosolization of dirt, pollen or mold.

Plants growing on top of univent, near window

8. Ensure plants have drip pans. Examine drip pans periodically for mold growth and disinfect with an appropriate antimicrobial where necessary. Keep plants away from the air stream.

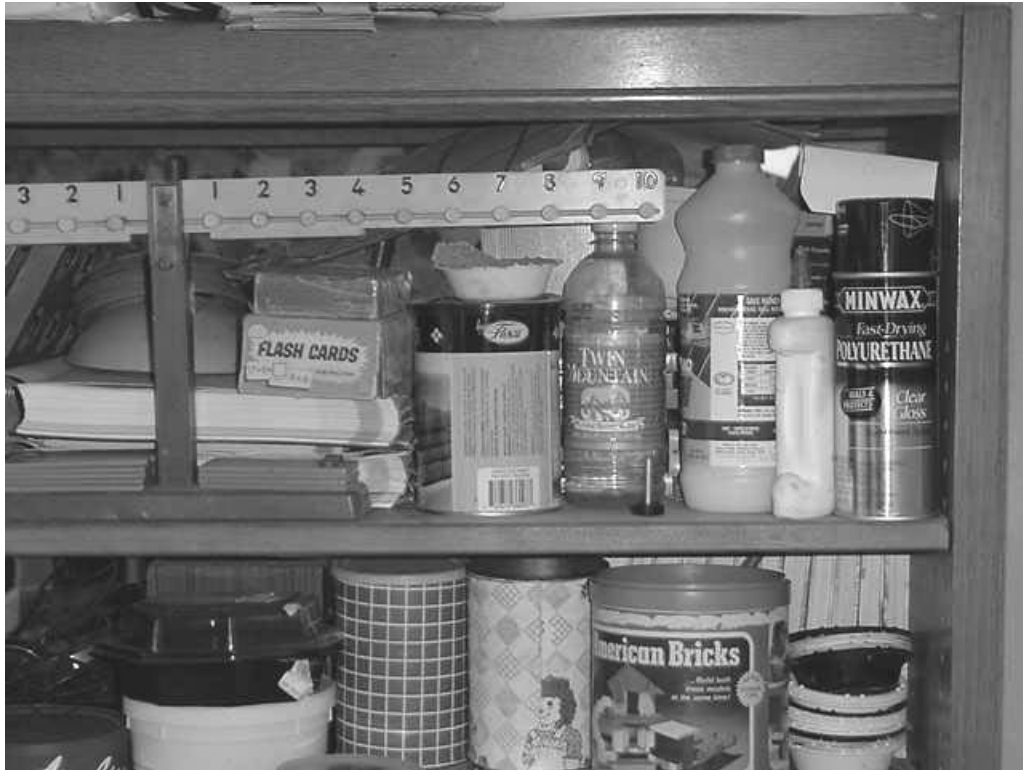
Picture 16

Cleaning products were found on countertops, in unlocked cabinets beneath sinks, and on shelves in some classrooms (Picture 16). Like dry erase materials, cleaning products contain VOCs and other chemicals that can be irritating to the eyes, nose and throat of sensitive individuals. Also of concern are unlabelled bottles and containers located under sink cabinets.

Cleaners and food containers stored in bookcase

Products should be kept in their original containers or the contents should be clearly labeled for identification purposes, especially in the event of an emergency.

10. Clean chalkboard/dry erase marker trays regularly to prevent the build-up of excessive chalk dust and particulate.
11. Store cleaning products properly and out of reach of students.

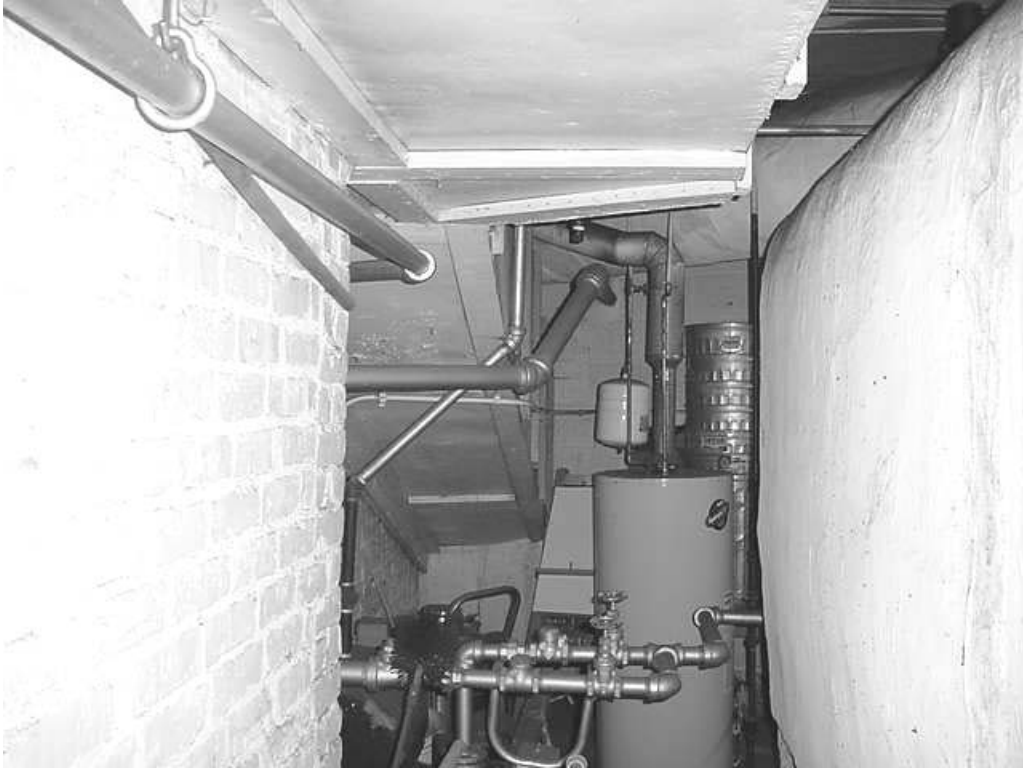
Picture 17

Other conditions that can affect indoor air quality were noted during the assessment. Pathways exist for boiler room odors and other materials to move into occupied areas. The boiler room can be accessed through a long, narrow hallway in the basement (Picture 17). There is no door separating the boiler room hallway from other portions of the basement. This allows for odors and materials from this room to move into other portions of the basement. Furthermore, a food service elevator is located at the entrance to the doorway of the boiler room (Picture 18). The elevator shaft can serve as a mechanism for odors and particles to move into upper level areas.

Hallway to boiler room

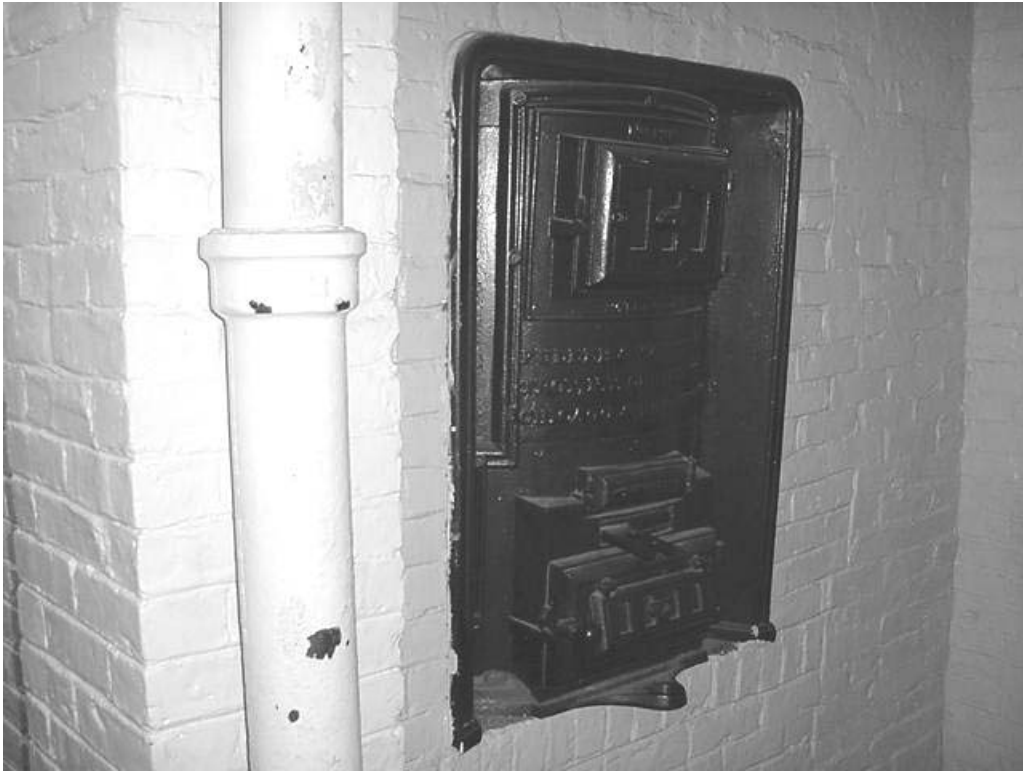
Picture 18

Service box in boiler room hallway

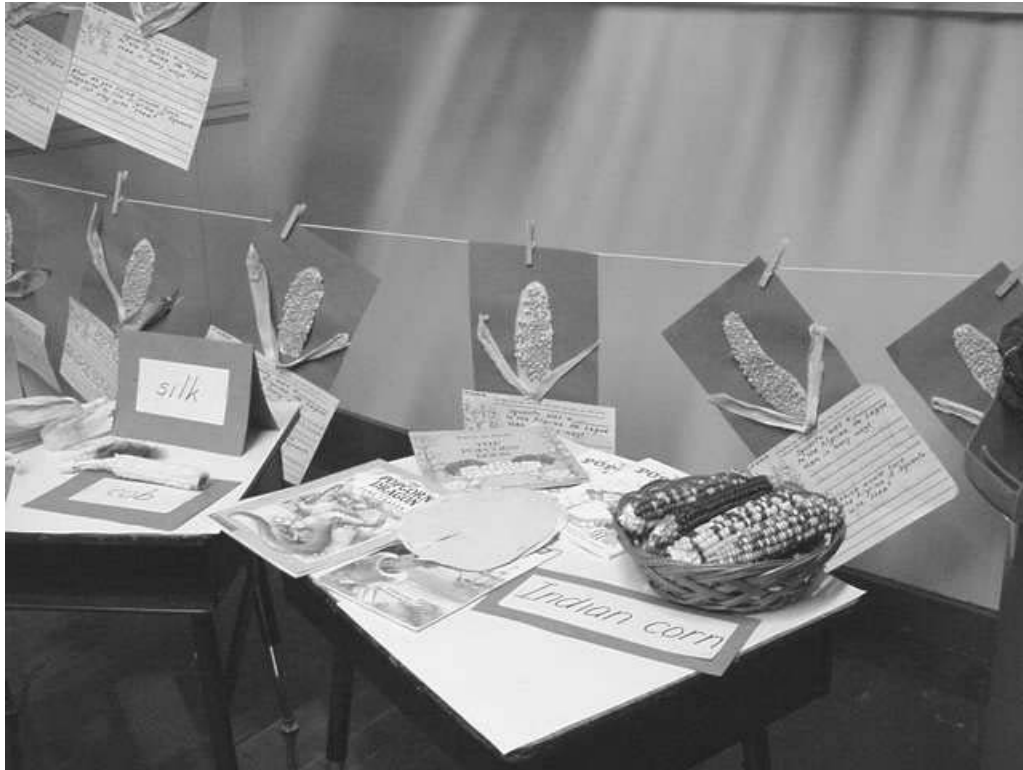
Picture 19

Food was apparently used in a number of art projects (Picture 19 and Picture 20). Food is an attractant to pests and rodents. Proper food storage is an integral component in maintaining indoor air quality. Food should be properly stored and clearly labeled. Moreover, food should be placed away from cleaning products, in separate storage areas. Reuse of food containers is not recommended, since food residue adhering to the surface may serve as an attractant to pests.

Food art

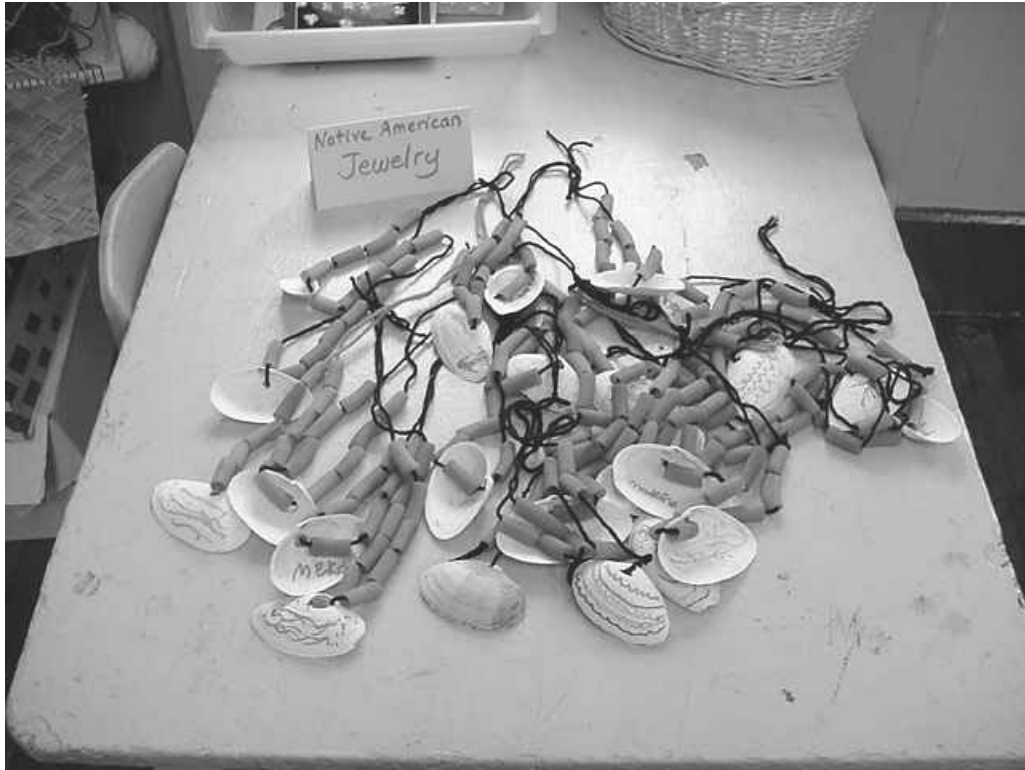
Picture 20

Pasta necklaces
